CASE HISTORY:

Historic Lighthouse on Hunting Island, South Carolina

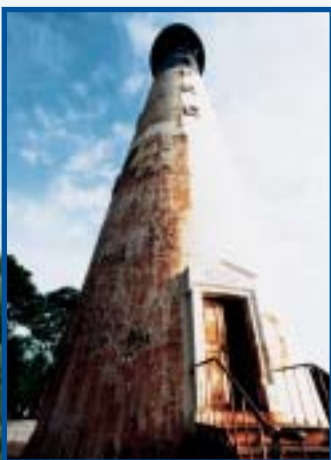
In 1981, a Rohm and Haas employee was vacationing on Hunting Island and noticed that the lighthouse was in bad disrepair. There were holes in the cast iron ranging in size from 1/4 to 2 inches in diameter. The alkyd coating that was applied seven years prior had deteriorated badly, embrittling and cracking, especially along the north side. Heavy rust spotting and run-down originating at the plate joints and the pitted areas had turned the once-attractive landmark into an eyesore. A complete restoration was planned.

Lighthouse in 1982 prior to restoration, showing heavy corrosion on northwest side

The first step in the 1982 restoration was to sandblast the cast iron plates back to bare metal. Thousands of holes were laboriously hand-filled using putty knives and an acrylic-modified cementitious compound which was designed to expand and contract with the metal. A red waterborne acrylic primer containing anti-corrosive pigments was applied to the clean steel, and followed by a white midcoat based on the same

acrylic resin. Then gloss waterborne acrylic topcoats were applied to match the historical color scheme – white on the bottom and black on top. The total dry film thickness was approximately 9 mils.

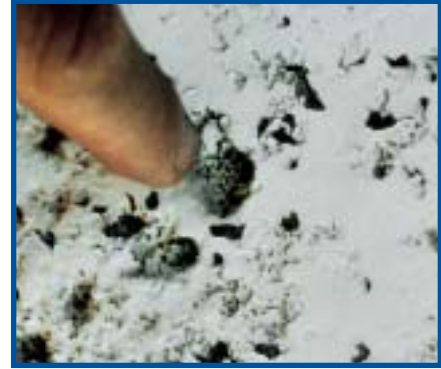
Close-up showing pits and holes in cast iron plates.

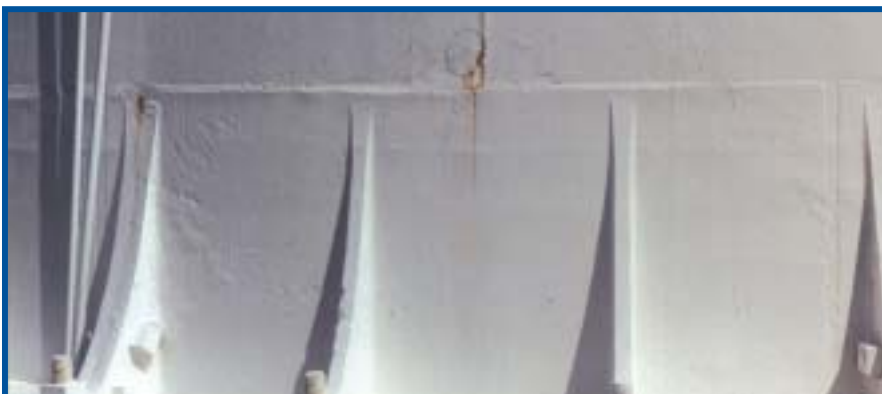
The Hunting Island Lighthouse was recently inspected in March of 2002. Overall, the lighthouse is in excellent condition. Only a few small rust spots were observed on the entire structure. The lower white section has chalked considerably, while the upper black section is doing very well with high gloss and no chalking. A small amount of mildew has once again started to

One of the few corrosion spots observed on lighthouse in 2002. This spot occurred at one of the plate seams.

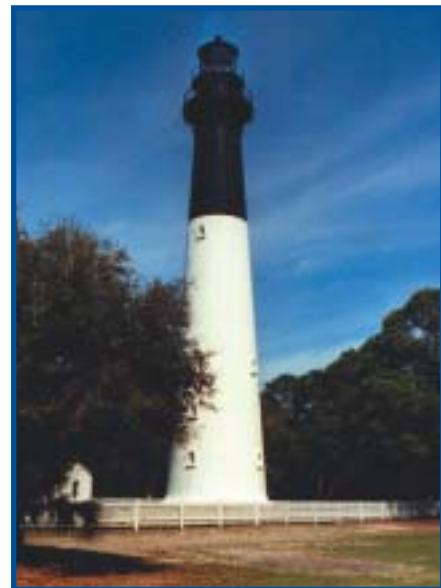
grow on the northwest side, but could probably be easily remedied with a bleach cleaning and pressure washing. Today, after twenty years of service, waterborne acrylic coatings are still protecting the Hunting Island Lighthouse from the elements, and provide an aesthetically pleasing exterior for the more than 1 million annual visitors to the Hunting Island State Park. After 127 years, this historic landmark deserves nothing less.

Lighthouse in March of 2002.
