WATERBORNE ACRYLIC RESINS FOR PROTECTIVE COATINGS

CASE HISTORY:

Neuse River Bridge in New Bern, North Carolina

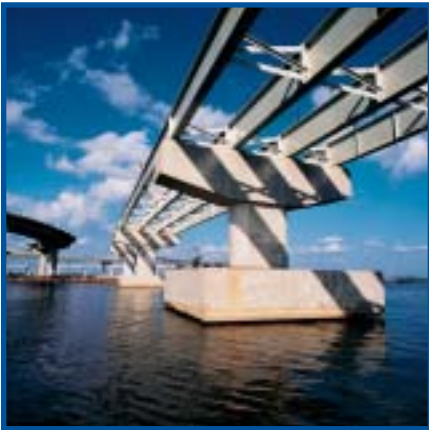
Bridge during construction.

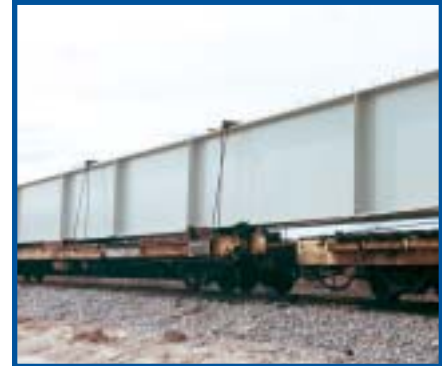
Shop painted beams waiting to be erected

The bridge consists of 879 steel girders painted with a four-coat waterborne acrylic paint system, consisting of 2 primer coats and two finish coats. All paints were applied in a shop to an SSPC SP-6 prepared surface, except for connection areas and touchup which were done on site. Structural steel fabrication and shop painting started in May of 1996 and continued through July of 1998. The steel beams were made in

Wisconsin and shipped by rail to the site. After construction, connections were blast cleaned and painted with the 4-coat system. In order to continue painting through cold weather, some of the connections were primed with a solventborne zinc-rich primer, then finished at a later time with the WB paints.

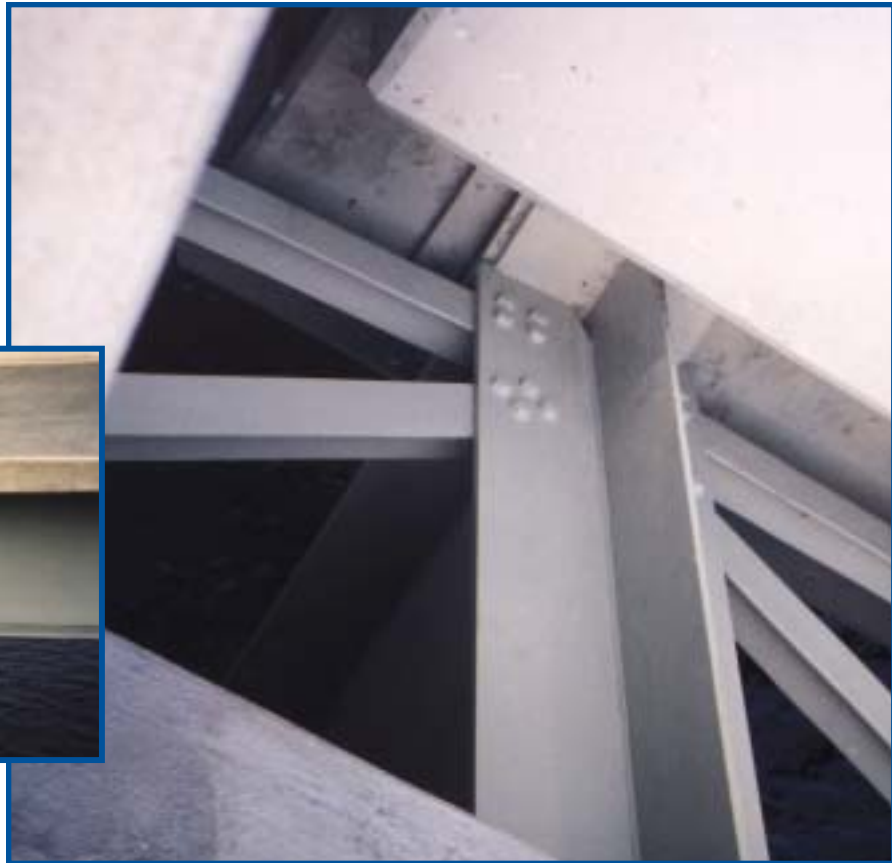
Picture taken in summer 2001.

In July 2001, an independent evaluation of the bridge was conducted. Areas inspected included some of the first girders to be painted. Overall, the paint system is doing very well, with no significant problems. Although there were numerous areas of damage to the coating system during the erection, the damage was easily repaired during the touchup operations. The coatings were found to be user-friendly during both their
