CASE HISTORY:

Historic Lighthouse on Hunting Island, South Carolina

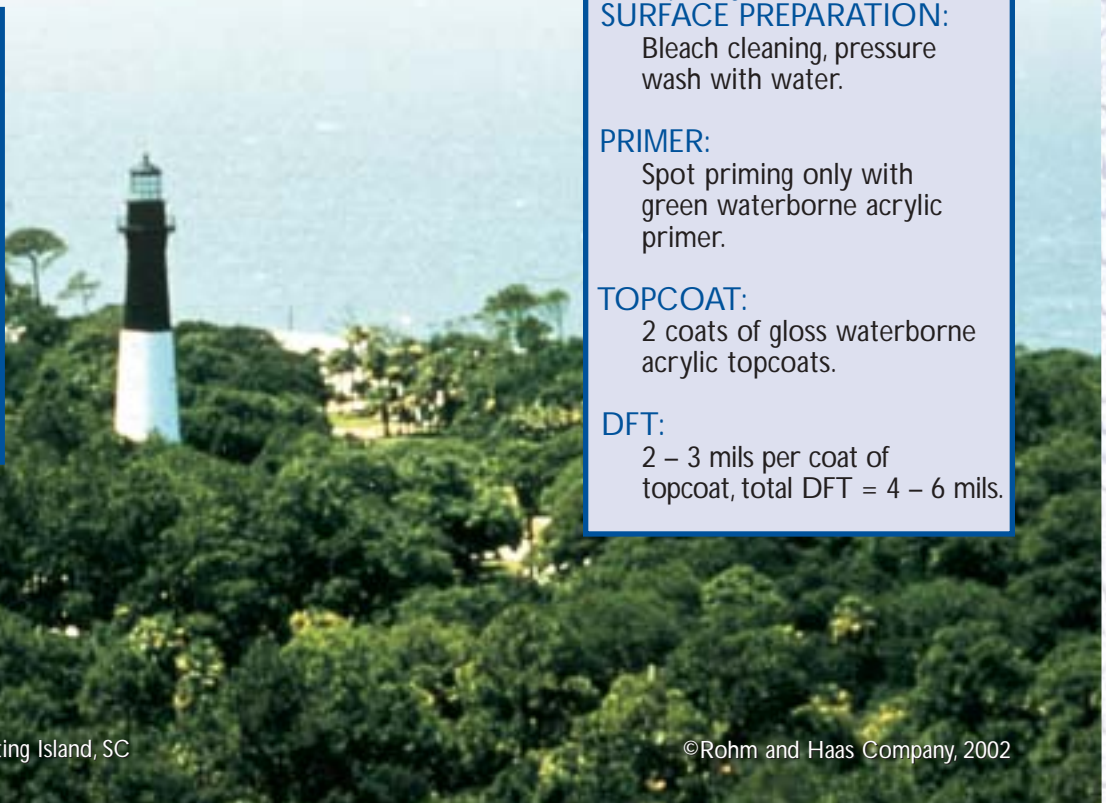
In 1981, a Rohm and Haas employee was vacationing on Hunting Island and noticed that the lighthouse was in bad disrepair. There were holes in the cast iron ranging in size from 1/4 to 2 inches in diameter. The alkyd coating that was applied seven years prior had deteriorated badly, embrittling and cracking, especially along the north side. Heavy rust spotting and run-down originating at the plate joints and the pitted areas had turned the once-attractive landmark into an eyesore. A complete restoration was planned.

Lighthouse in 1982 prior to restoration, showing heavy corrosion on northwest side

The first step in the 1982 restoration was to sandblast the cast iron plates back to bare metal. Thousands of holes were laboriously hand-filled using putty knives and an acrylic-modified cementitious compound which was designed to expand and contract with the metal. A red waterborne acrylic primer containing anti-corrosive pigments was applied to the clean steel, and followed by a white midcoat based on the same
